RIDGEBURY LAKE DAM

(NDI I.D. No. PA-00727
PENNDER I.D. No. 8-57)

PHASE I INSPECTION REPORT
NATIONAL DAM INSPECTION PROGRAM

JULY 1980

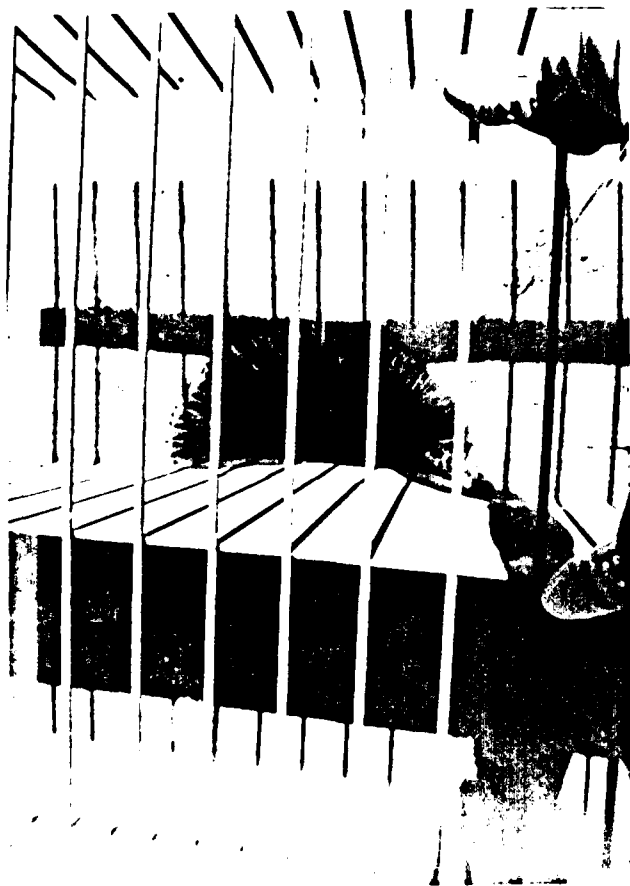
2. Service Spillway. The service spillway is considered to be in good condition. Minor surface corrosion was observed on all metal surfaces associated with the structure (see Photographs 3, 5, 6 and 8).

PHOTOGRAPH 5 Close-up view of the drop inlet service spillway.

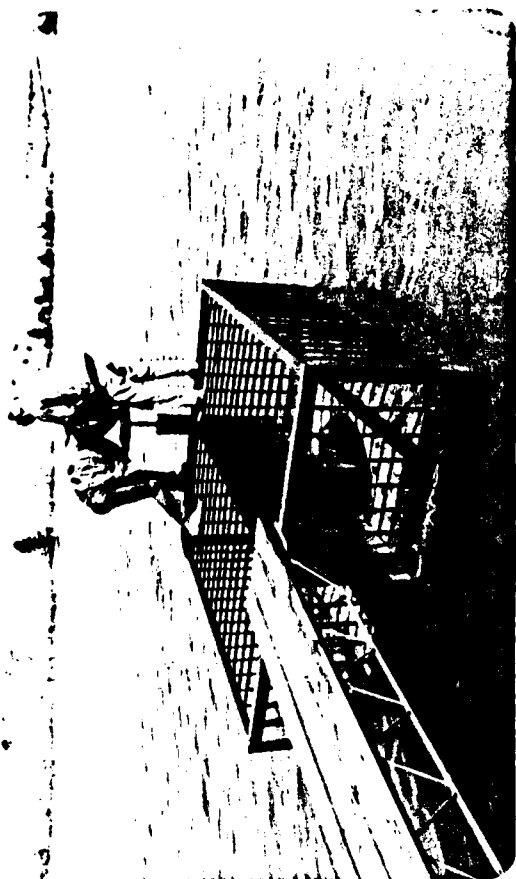
6

3. Reservoir Drain. The reservoir drain was operated in the presence of the inspection team and is considered to be in good condition. Evidence of minor surface corrosion was observed on the manual operator and gate stem (see Photograph 6).
